2015 Chief of Naval Operations Environmental Competition Award
Award Category: Sustainability, Industrial Installation

Combating Hydrogen Sulfide and Accelerated Corrosion in Fuel Tanks and Piping

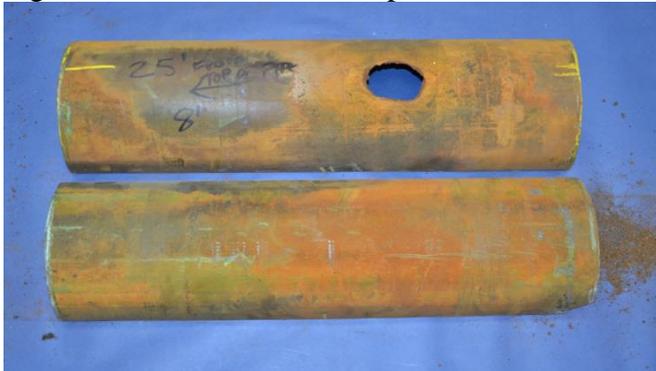
Figure 8: Section of Failed Pipe

After processing the treated H₂S for one month, an 8" pipe used to transfer the oily water failed. The section of pipe, Figure 8, was sent to a forensic laboratory for diagnostic analysis. The examination and testing of the failed pipe concluded the failure was likely caused by internal pitting from microbiological induced corrosion and oxygenated water. The presence of water and sediment accumulating at the low points of the pipe corroded the unprotected carbon steel. The sediment accumulation led to growth of sulfur reducing bacteria (SRB) and accelerated corrosion caused by microbiological induced corrosion (MIC). All three criteria necessary for MIC were present in the pipe, i.e., elevated sulfur, elevated SRB, and tunneling within the corrosion pits. The failed pipe had been in service for less than three years.

The laboratory determined that sediment accumulation was caused by a stagnant oily water mixture in the pipe which is a frequent recurring problem caused by intermittent pumping operations. When allowed to stagnate, the oil and water separated and the particulate settled out of the solution onto the bottom of the pipe causing pipe failure at a pipe low point. DNA testing using energy dispersive spectroscopy concluded that anaerobic SRB and oxygenated water contributed to the accelerated corrosion and ultimate failure of the pipe.

Steel pipe without an interior coating is susceptible to corrosion, and corrosion rates can be very high resulting in premature pipe failure. Figure 9 depicts how microbiological SRB corrosion occurs on carbon steel piping. An American Petroleum Institute (API) 570 inspection of the total 2,800 feet of piping was conducted in October 2015. A significant number of additional corrosion issues were discovered. Meanwhile, the pipe has been taken out of service pending a full replacement of the pipe with internal coated piping.
